ROSEDALE TREATMENT PLANT

Existing Condition 11/8/02

TANNERY TREATMENT PLANT

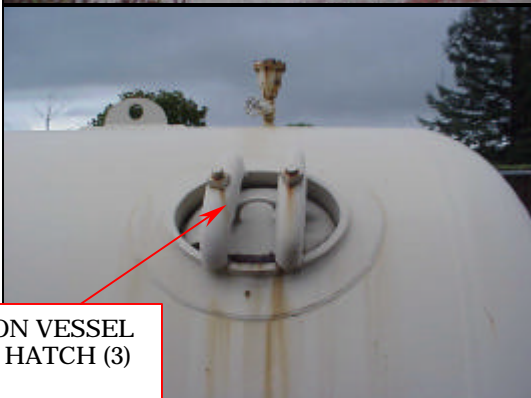
REACTION VESSEL
ACCESS HATCH (3)

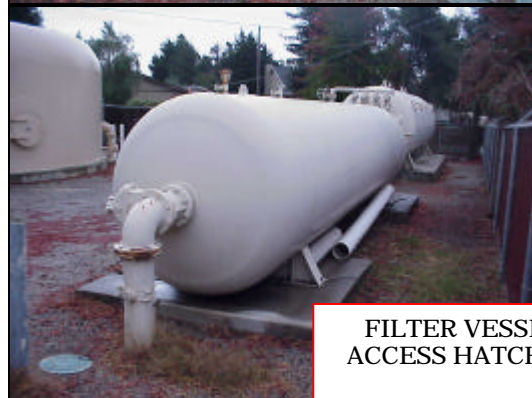
FILTER VESSEL
ACCESS HATCH (4)

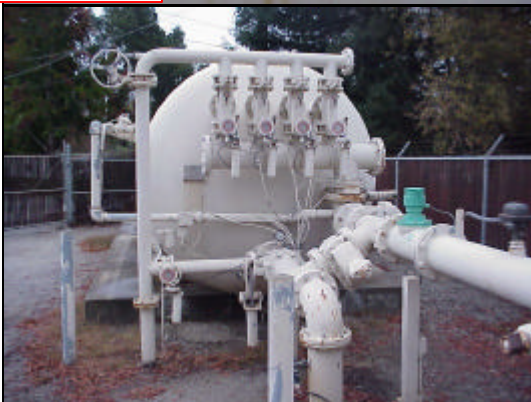
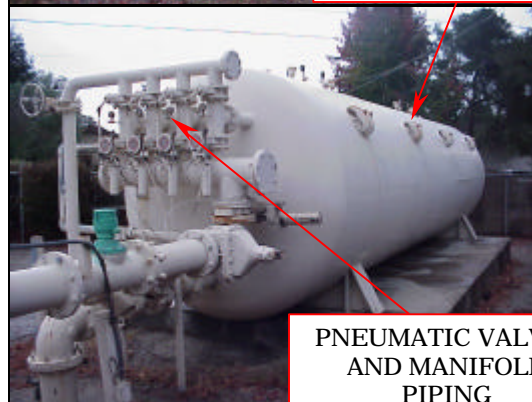
PNEUMATIC VALVES
AND MANIFOLD
PIPING

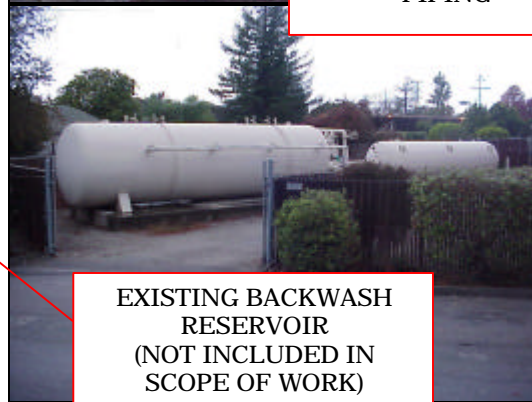
EXISTING BACKWASH
RESERVOIR
(NOT INCLUDED IN
SCOPE OF WORK)

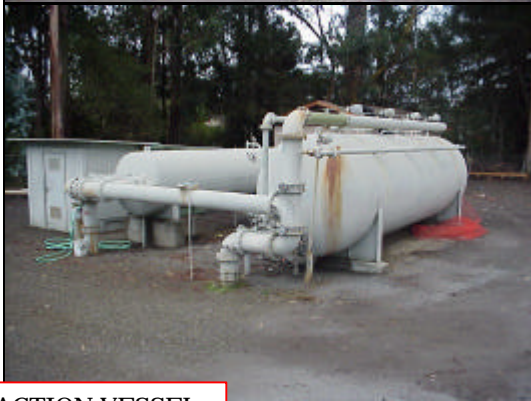
REACTION VESSEL
ACCESS HATCH (2)

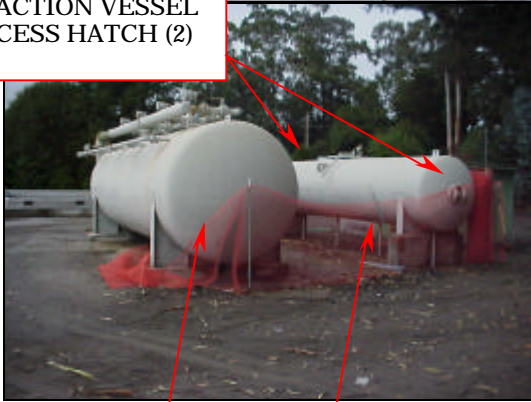
FILTER VESSEL

REACTION VESSEL

MANIFOLD PIPING AND
PNEUMATIC VALVES

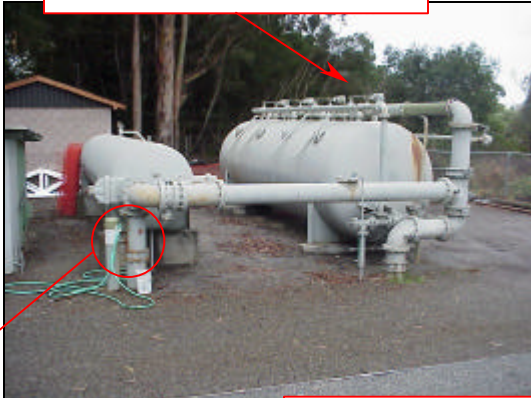
FILTER VESSEL ACCESS
HATCH (4)
