**CWO 15-126, HEADQUARTERS PARKING LOT EXPANSION &
INTERIOR OFFICE REMODELS**

**Appendix A: Limited Asbestos & Lead Paint Survey Report,
September 26, 2014, Revised October 10, 2014.**

Limited Asbestos & Lead Paint Survey Report

Site: 5180 Soquel Drive, Soquel, California

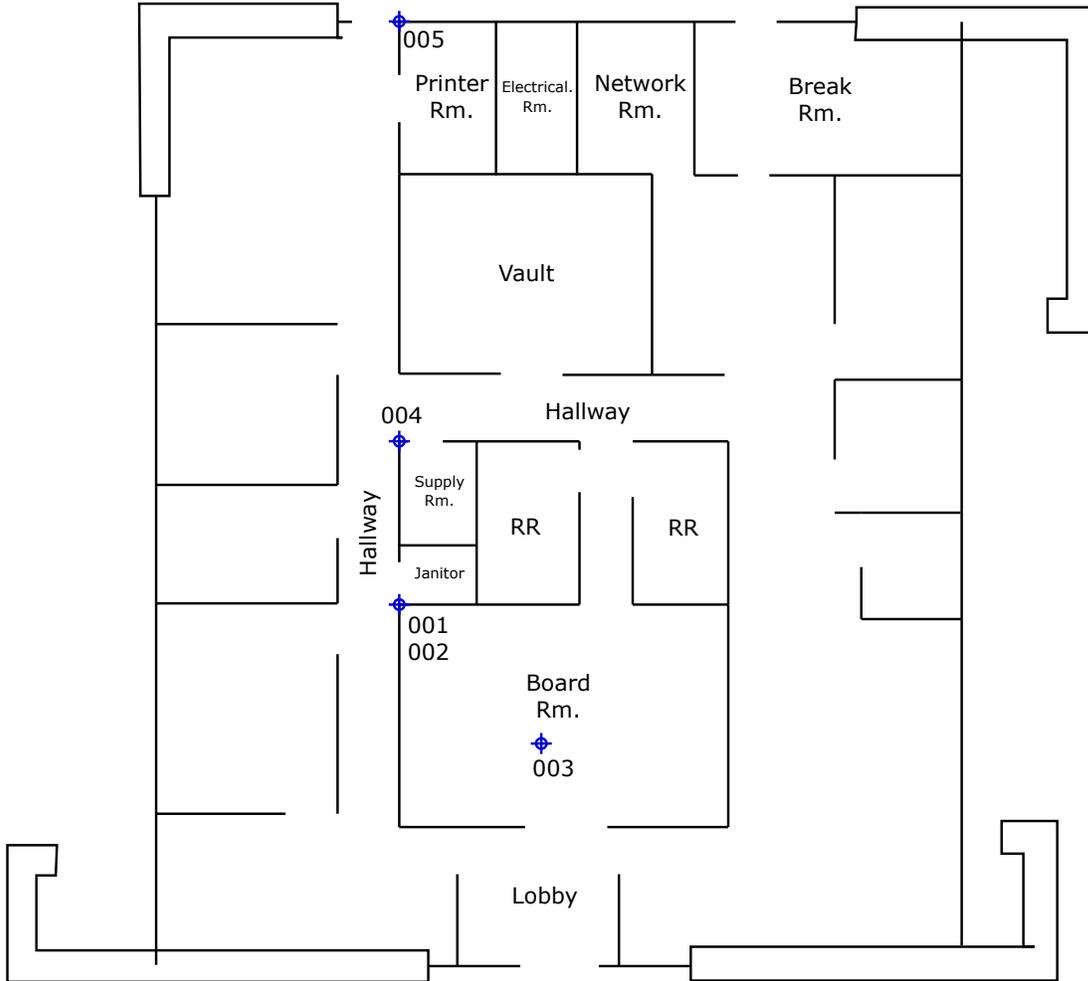
FIGURE NO. **1**

- * **In the administrative building, the joint compound, associated with the drywall system on all walls expected to be impacted by the renovations, contains 2% Chrysotile asbestos. The removal of drywall in this building will generate friable, Regulated Asbestos Containing Material (RACM). The ultimate quantity of removal will be determined by the contractor performing the renovation work.**

Asbestos Summary Table				
Asbestos Material	Locations	Analytical Results	Classification	Approximate Quantity for Removal
Drywall / Joint Compound	Printer Room Board Room Passage (opposite board room) Note: Based on the results, all drywall in the administrative building should be considered to be asbestos containing unless future comprehensive testing is conducted.	Joint Compound: 2% Chrysotile	RACM	To be determined by scope of renovations

A State of California, Division of Occupational Safety & Health (DOSH) licensed asbestos removal contractor must be used to handle any materials with an asbestos content of greater than 0.1% ([Asbestos Containing Construction Material](#)). All work must be conducted in strict accordance with Cal-OSHA's asbestos standard, [8 CCR 1529](#) and the requirements of the Monterey Bay Unified Air Pollution Control District's (MBUAPCD) [Rule 424](#). Waste must be disposed of in the correct landfill for the classification of asbestos being removed.

If greater than 160 square feet of RACM will be removed as part of the renovations, a notification to Monterey Bay Unified Air Pollution Control District (MBUAPCD) must be submitted ten day prior to beginning the work. **All asbestos removal and disposal must occur in strict accordance with EPA (MBUAPCD) and OSHA requirements, regardless of whether a notification is required. This report must remain onsite for the duration of the renovation project.**

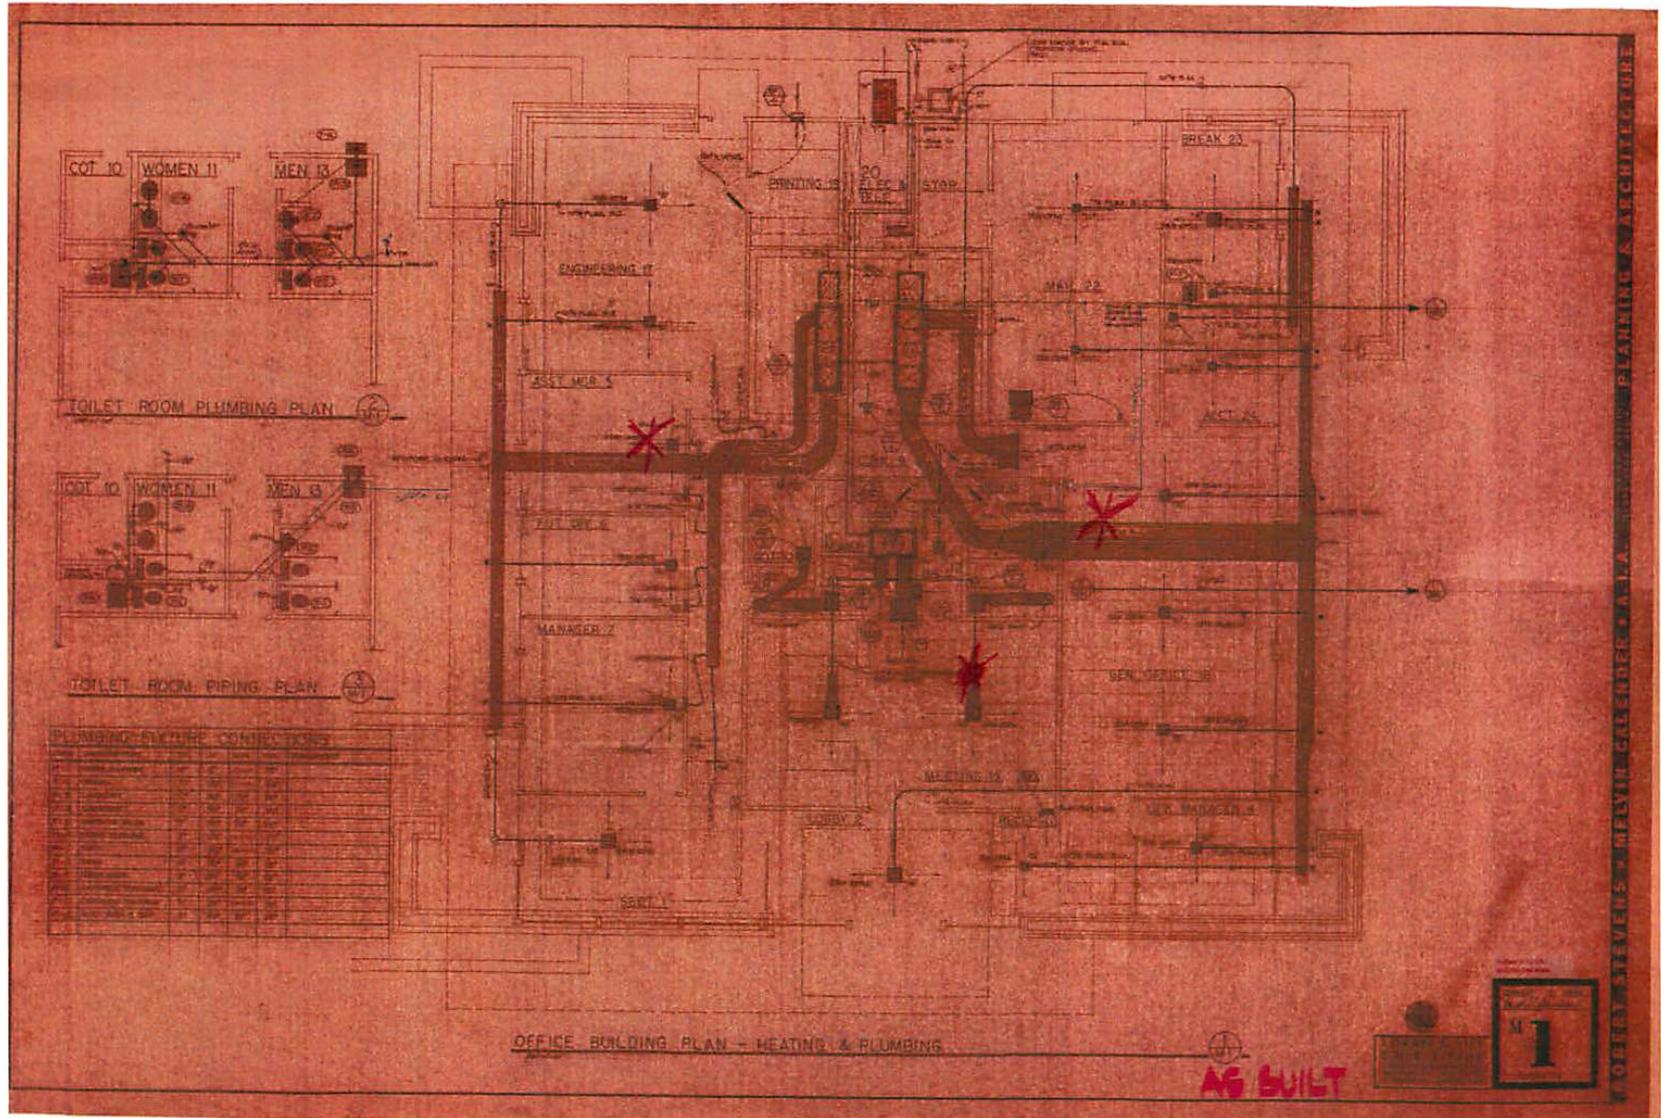
On the second site visit, we inspected the HVAC system from three accessible areas. Ducting was observed to be a combination of metal rigid duct and plastic flex duct. The ducting is insulated in fiberglass.

Note, we had limited access to the HVAC system, though all ducting appears to be insulated in fiberglass. Should future impact to the HVAC system occur, it should be noted that white tape or white corrugated cardboard type material may contain asbestos. See the plan attached to this report for our inspection locations. If any additional suspect material is observed, do not disturb it until S Tech can assess the material.
